This Field Bulletin describes how to eliminate the problem of a sudden power shutdown of the 256.

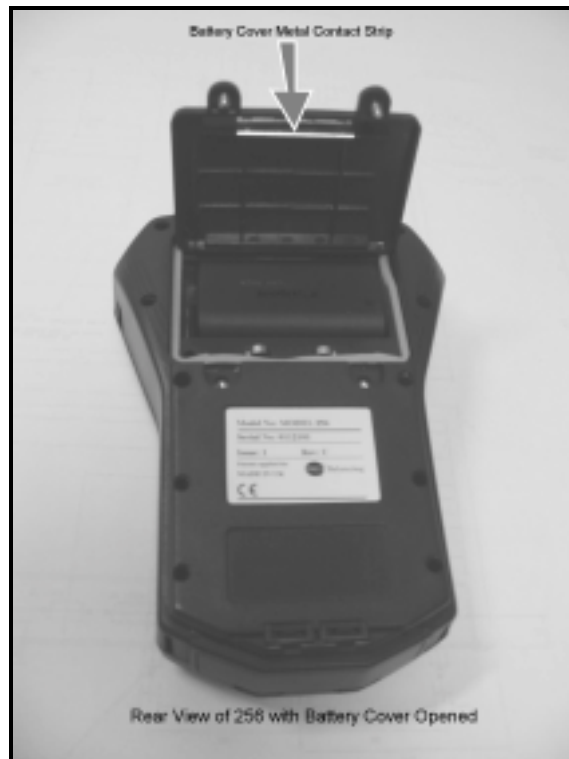
Figure 1 - Rear of 256 with Battery Cover Open

It is possible for a 256 to suddenly shut down during normal use even though the battery has a sufficient charge. The problem occurs when a metal strip on the inside of the rear battery cover loses electrical contact with switch contacts inside the 256. This can happen when the user applies pressure to certain areas on the back of the 256 battery cover.

1. Make sure that the power to the 256 is turned off.
2. Place the 256 face down on a soft clean surface so that you can see the battery cover on the rear of the instrument.
3. Use a flat bladed screwdriver to loosen the two screws holding the battery cover to the back of the 256. Remove the battery cover from the 256.

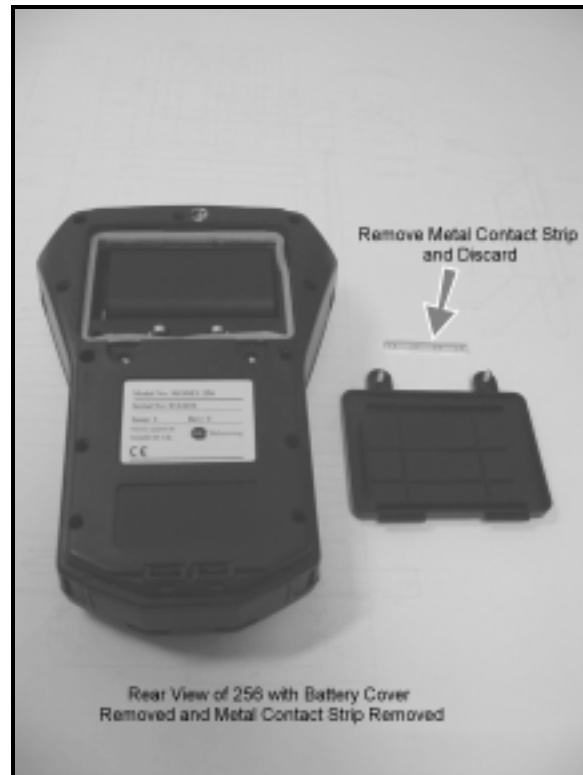
**Figure 2 - Metal Contact Strip Removed from Battery Cover**

4. Locate the metal contact strip that is attached to the plastic rib on the inside of the battery cover. Use a flat bladed screw driver to pry the metal strip off the rib. Be careful to avoid physical injury when removing the strip.

5. Discard the metal contact strip
6. Place the plastic battery cover into the back of the 256 and secure with the two holding screws.
7. The procedure is complete.
